REPORT

№ 7032/13.08.2003

About: Ultrasonic non-destructive testing

Object: *Galata gas field development wellhead platform*

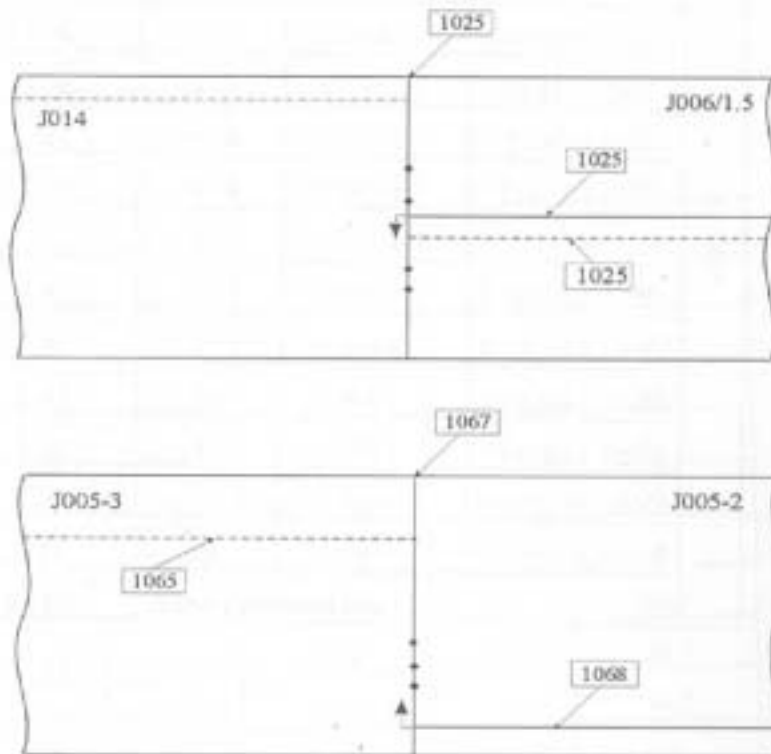
Scheme of Situation of Detected and Repaired Discontinuities

Item	Weld №	Part for repairing	Kind of imperfections and depth location
J014-J006/1.5	1025	(81 + 83); (87 + 89); (-10,5 + -12); (-52 + -54)	single; D = (13,3 + 14) mm
J005/1.2-J005/1.3	1067	(81 + 83); (90 + 92); (134 + 136)	single; D = (11 + 12) mm
Second controlled length /dm/:			13,5

*Unacceptable imperfections detected during the control was repaired and controlled again.
 During the second control unacceptable imperfections are not detected.*
